**Assessment of glenoid bone loss and other osseous shoulder pathologies comparing  
CT-like MR-images with conventional CT**

**ELECTRONIC SUPPLEMENTARY MATERIAL**

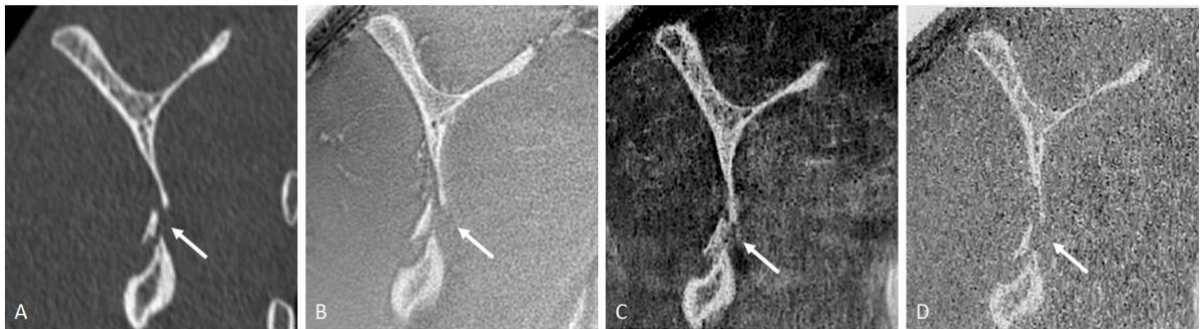
**Supplementary Figure 1**

Complex scapula fracture of a 23-year-old patient after acute trauma showing sagittal images of a conventional CT scan (**A**) compared to inverted CT-like images acquired using UTE (**B**), FRACTURE (**C**) and T1 GRE sequences (**D**). Note the accurate presentation of the fracture borders on the CT-like MR sequences compared to CT (white arrows).
